10 October 2006
Issue Number 0406

Serious injury (leg amputation) in UK Paper Mill

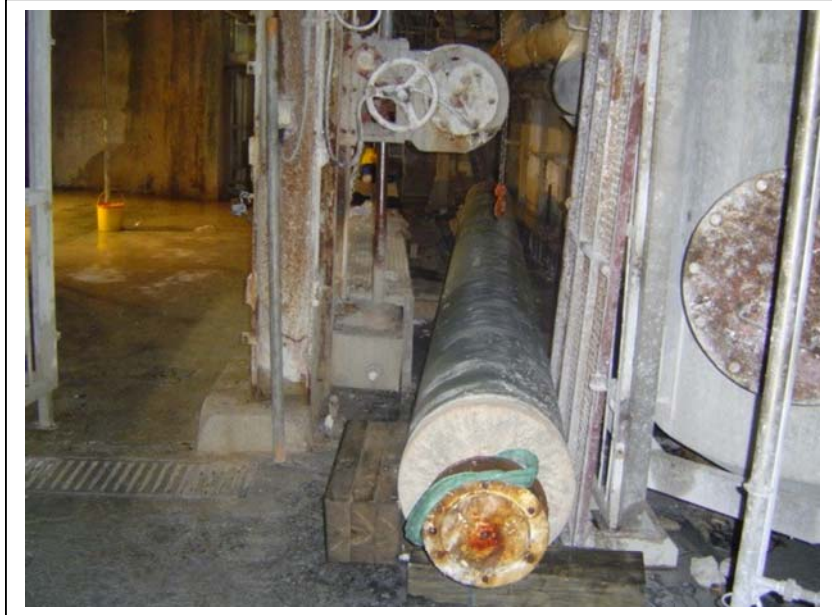
Photo 1 - Area in basement where accident occurred

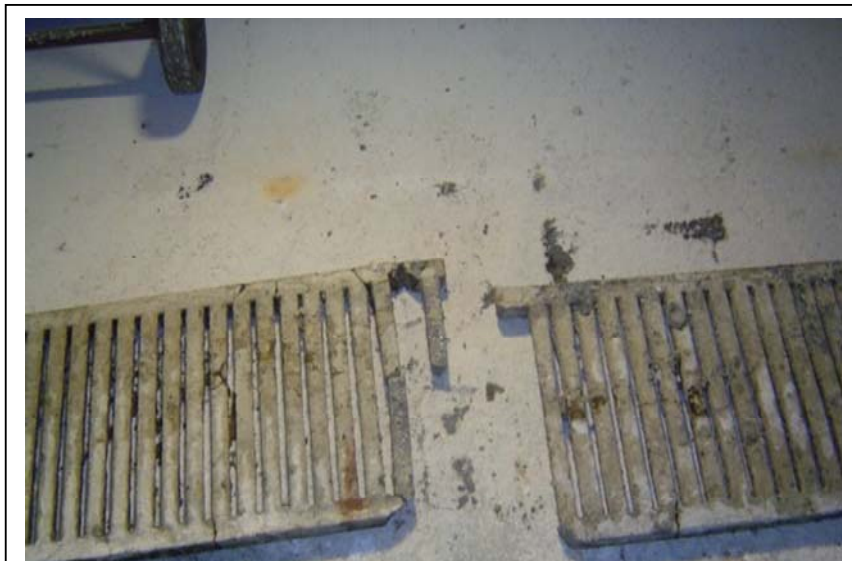
During a two day planned engineering shut the 1st press felt roll was to be replaced for the first time in 8 years. The incident happened at 14.40 when a 4 tonne press roll was lowered onto a 750mm long two wheeled trolley with narrow (50mm) wheels. This was being manoeuvred out of a constrained area in the basement (**Photo 1**) The cast iron drain cover failed under the weight of the roll plus trolley and the trolley wheel dropped into a drain run causing the roll to pin the contractor against a concrete plinth. (**Photo 2**)

Photo 2 - Damaged cast iron drain cover

- A system of inspecting/maintaining drain covers and consider replacement of potentially brittle cast iron covers which could have invisible internal fractures / faults;
- A system to re-assess risk in all areas after any changes in procedures/technology to ensure redundant equipment etc is removed because it could potentially increase risk by creating an obstruction during future works;
- Work towards reducing hazards in all constrained area where work has to be undertaken.

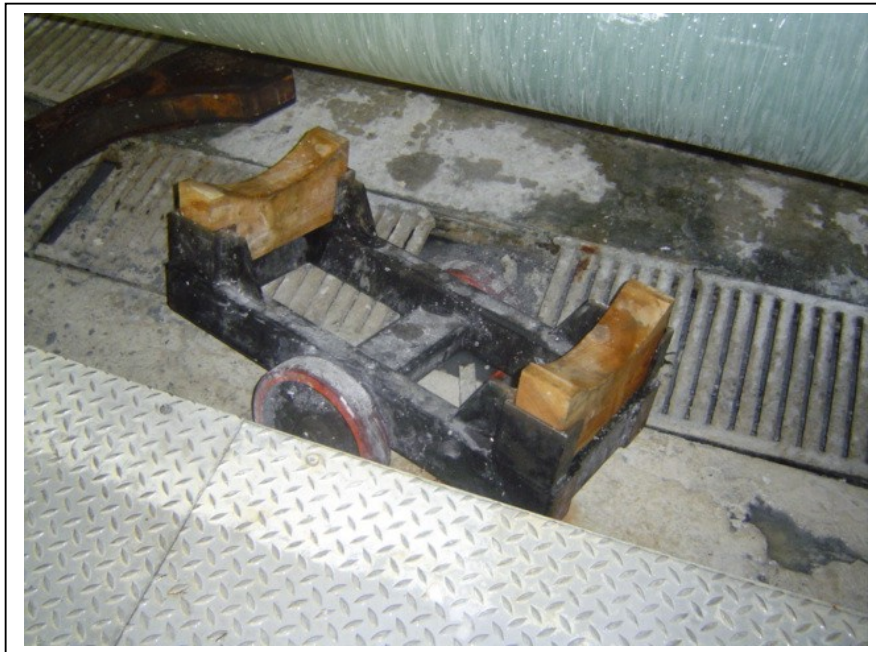
The accident happened as the roll was lowered onto a 2-wheeled trolley that supported the roll about 3 – 4 feet from the backside end of the roll. (**Photo 3**) The front of the roll was supported with a Hyster 3 ton fork lift truck. The roll had moved about 6 feet when some of the team heard a cracking sound, consistent with the drain cover giving way. The trolley carrying the roll tilted towards the dry end trapping the contractor who was between the roll and the plinth running the length of the dry end side of the machine. (**Photo 4**) The roll pinned his right lower leg against the concrete plinth causing multiple open wound fractures.

Photo 3 – Trolley used to support the roll

- With trolleys (especially short based ones used for manoeuvring in constrained areas) ensure, in the event of a failure, that there is some 'belt and braces' method to spread the load. Consider lengthening trolley (in this instance to say 1200mm from 750mm), same width, same size centre axle wheels plus a smaller set of wheels at either end to spread the load IF such an incident occurs in the future;

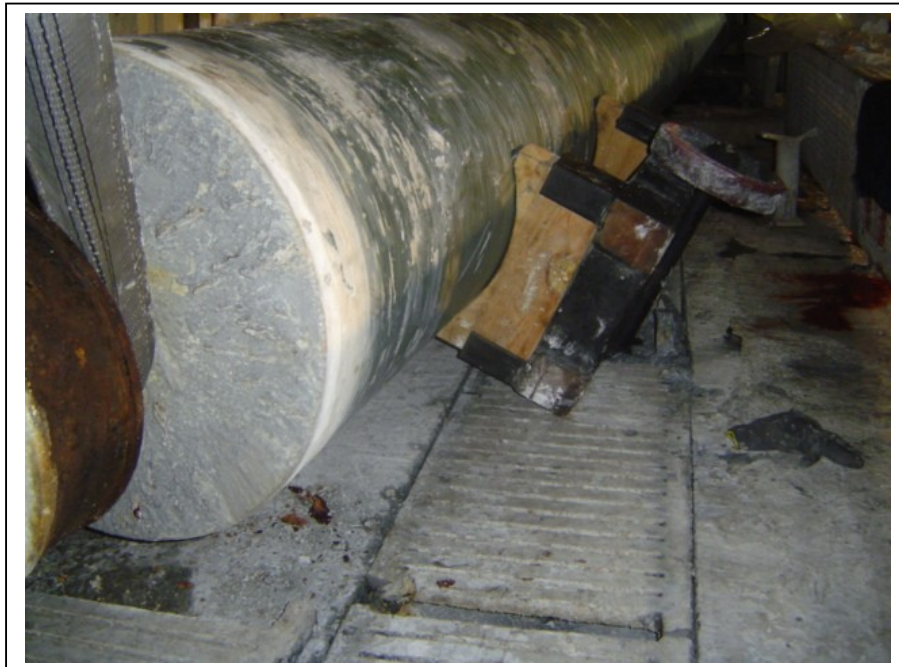
Photo 4 – Overturned trolley trapping the contractor between roll and the plinth

- Emphasize by training that **NO ONE** is to stand in or walk through the area of danger when a piece of kit is being moved and there are solid objects to be crushed against in the near vicinity i.e. treat all such activities as if they are lifting operations throughout.
